TECHNCIAL NOTE no.: 55

Product:	Engine Fan Support
Part number:	5FR121207B
To:	Cupra Leon VZ TCR
Date:	28/05/2024

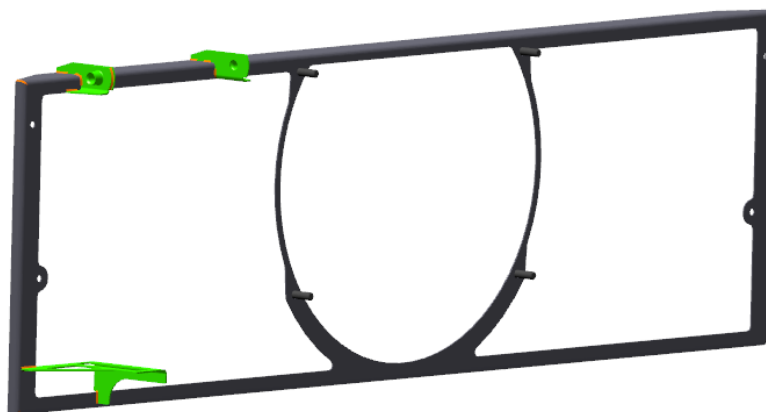
We have received reports of a radiator breakage after a frontal crash of a car model CUPRA LEON VZ TCR. It is always difficult to assess how serious the impact was in relation to the damages caused.

1. Customers to remove the old gearbox radiator supports (**in green**) in all existing CUPRA LEON VZ TCR cars. The lower one is the critical one.

As prevention to avoid further engine radiator punctures, we propose the following actions:

2. CUPRA to modify the design. Soon we'll announce the availability of a renewed engine fan support. This new one, will be suitable for all cars models.

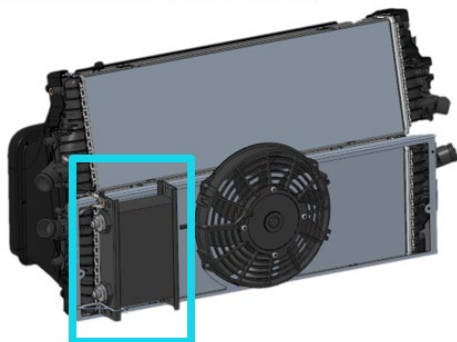
CUPRA **LEON COMPETICION** gearbox radiator position

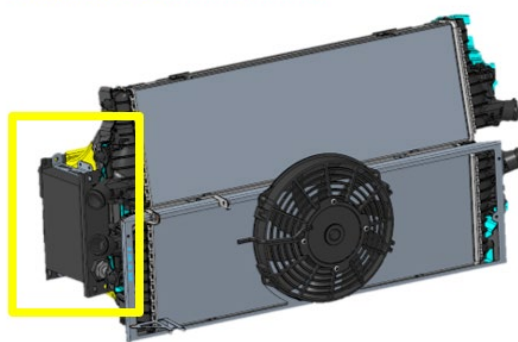
CUPRA **LEON VZ TCR** gearbox radiator position
